HMAS SYDNEY II SEARCH PRESS ROOM

6th March 2008 Report

David Mearns - Search Director, The Finding Sydney Foundation

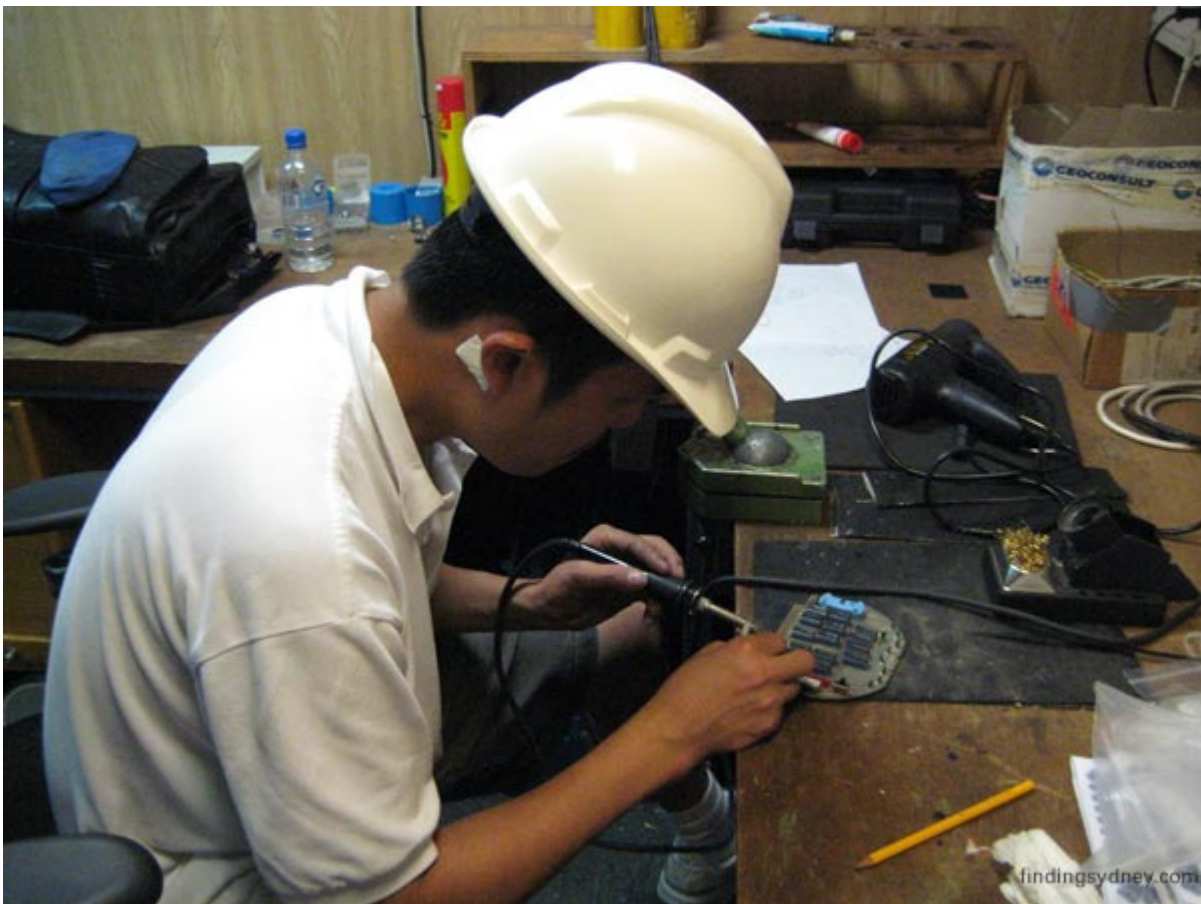
Above Photograph - Carter Le, Williamson & Associates Electronic Engineer making repairs to a printed circuit board

The remaining problems were far trickier to troubleshoot as they involved the delicate electronics of the SM30 towfish that are the domain of Carter Le, the electronics engineer who is a key member of the Williamson & Associates sonar team. Carter worked many hours throughout the day finding and fixing two faults after which the only thing left to do was deploy the towfish again to see if the imagery was good enough to resume searching. Several hours later and with 6,000 metres of towcable deployed the turn we dreaded had just taken place.

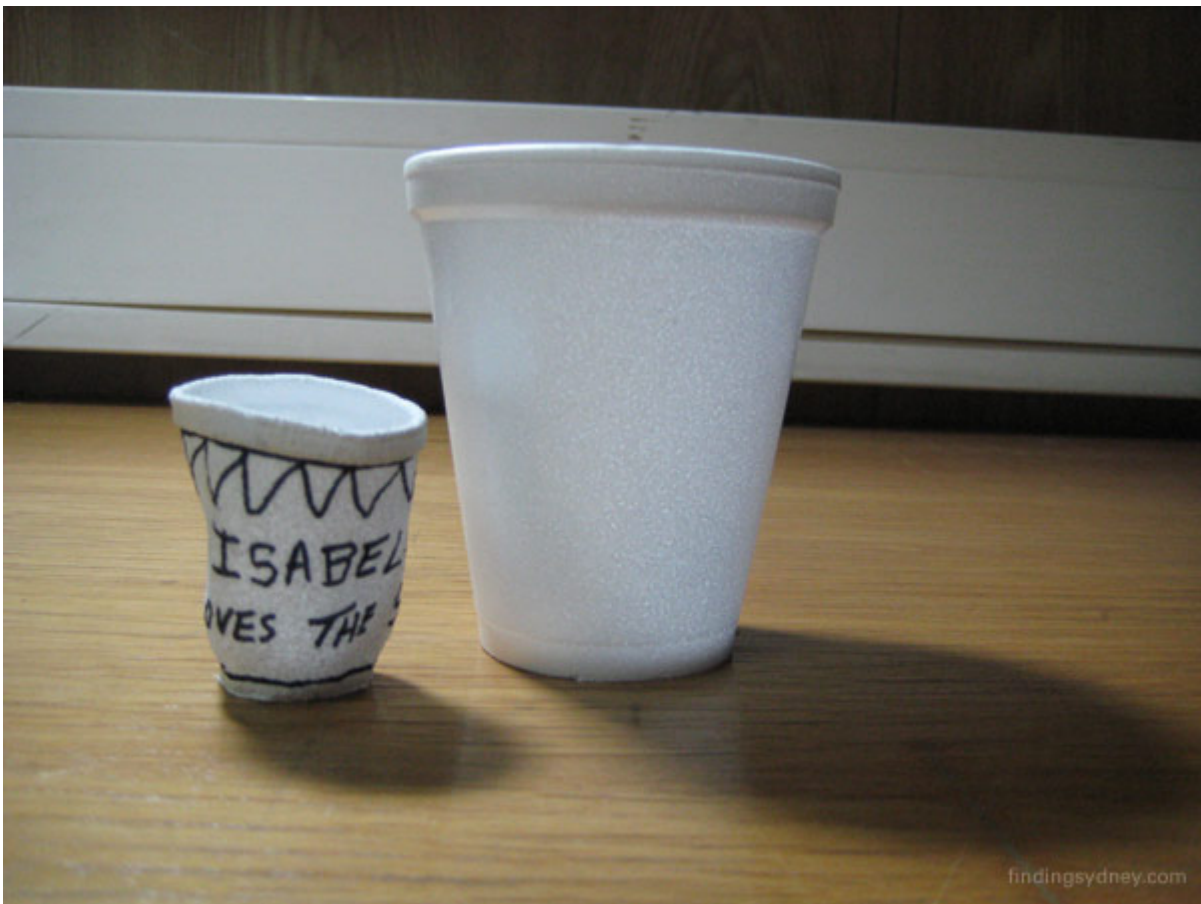
Above Photograph - two polystyrene cups, before and after being squeezed by several thousand metres of water pressure.

Prior to its launch before the first run, the Williamson crew placed a number of polystyrene cups, which they had written their names on, in a small bag attached to the sonar. When it was recovered, the cups were retrieved but had been compressed in size to about one third of their original size. Apparently this is due to the air being squeezed out of them by the intense water pressure. Many of the cups had been adorned with artwork and logos and they will no doubt become memorable souvenirs of this expedition.
